Effect of Roof Material on Water Quality for Rainwater Harvesting Systems – Additional Physical, Chemical, and Microbiological Data

Report

Texas Water Development Board

January 2011

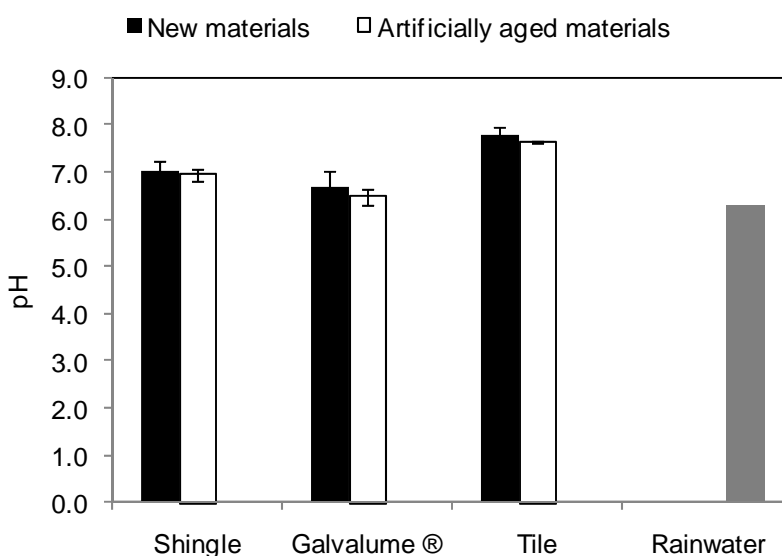
Figure 5-2. pH in the coupon study, including the starting rainwater and the new and artificially aged roofing coupons. Error bars represent one standard deviation from triplicate coupon experiments.

coupons $\sqrt{\frac{(7.1-6.7)^2+(6.4-6.7)^2+(6.6-6.7)^2}{2}}$ are summarized in Figure 5-2.

The aging process did not appreciably affect pH (Figure 5-2). The new and artificially aged coupons yielded near-neutral pH values, and all roofing materials resulted in a pH increase over that of the starting rainwater (before it was exposed to the roofing coupons).

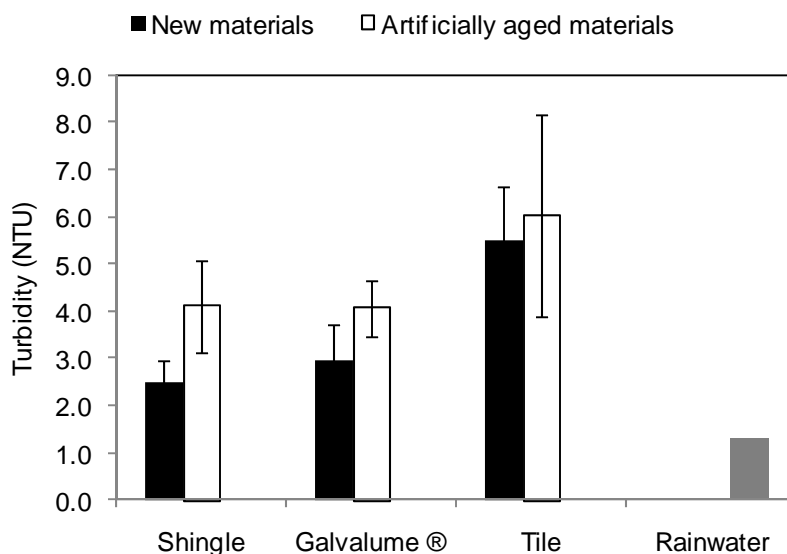
Figure 5-4. Turbidity in the coupon study, including the starting rainwater and the new and artificially aged roofing coupons. Error bars represent one standard deviation from triplicate coupon experiments.

The aging process slightly increased the average release of particulate matter from the asphalt fiberglass shingle, Galvalume® metal, and concrete tile roofing coupons (Figures 5-4 and 5-5). All roofing materials yielded an increase in particulate matter concentrations as compared to that of the starting rainwater.

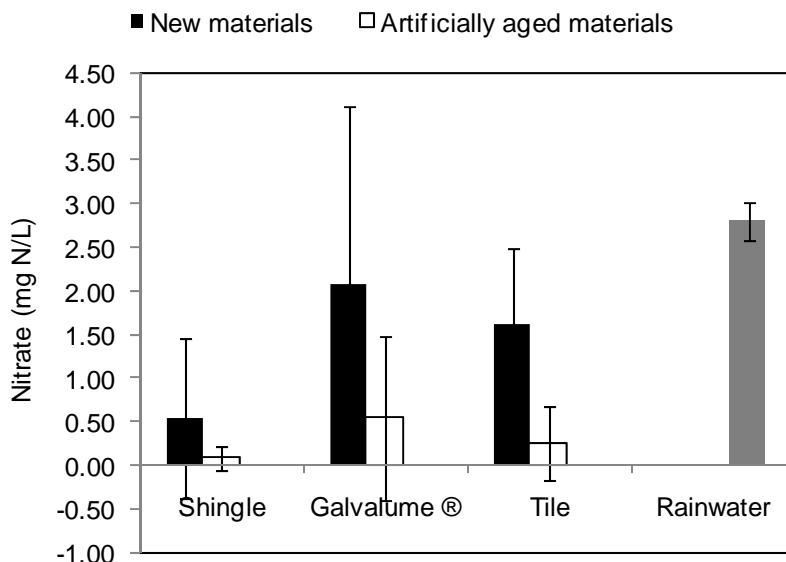
Figure 5-7. Nitrate in the coupon study, including the starting rainwater and the new and artificially aged roofing coupons. Error bars represent one standard deviation from triplicate coupon experiments.

The aging process decreased the average nitrate released from the asphalt fiberglass shingle, Galvalume® metal, and concrete tile roofing coupons, although the error bars indicate considerable variation among the triplicate coupons (Figure 5-7). The nitrate concentrations from the new and artificially aged roofing coupons were generally lower than that of the starting rainwater (Figure 5-7), suggesting that these roofing materials act as a sink for nitrate. The bulk of nitrate in harvested rainwater likely comes from atmospheric deposition, as previous work has shown that nitrate concentrations in harvested rainwater generally increase with the length of the antecedent dry period (Mendez et al., 2011).
