CAMERON COUNTY DRAINAGE DISTRICT 5 TEXAS WATER DEVELOPMENT BOARD FLOOD PROTECTION PLANNING STUDY FINAL REPORT

September 13, 2019

**Cameron County
Drainage District 5**

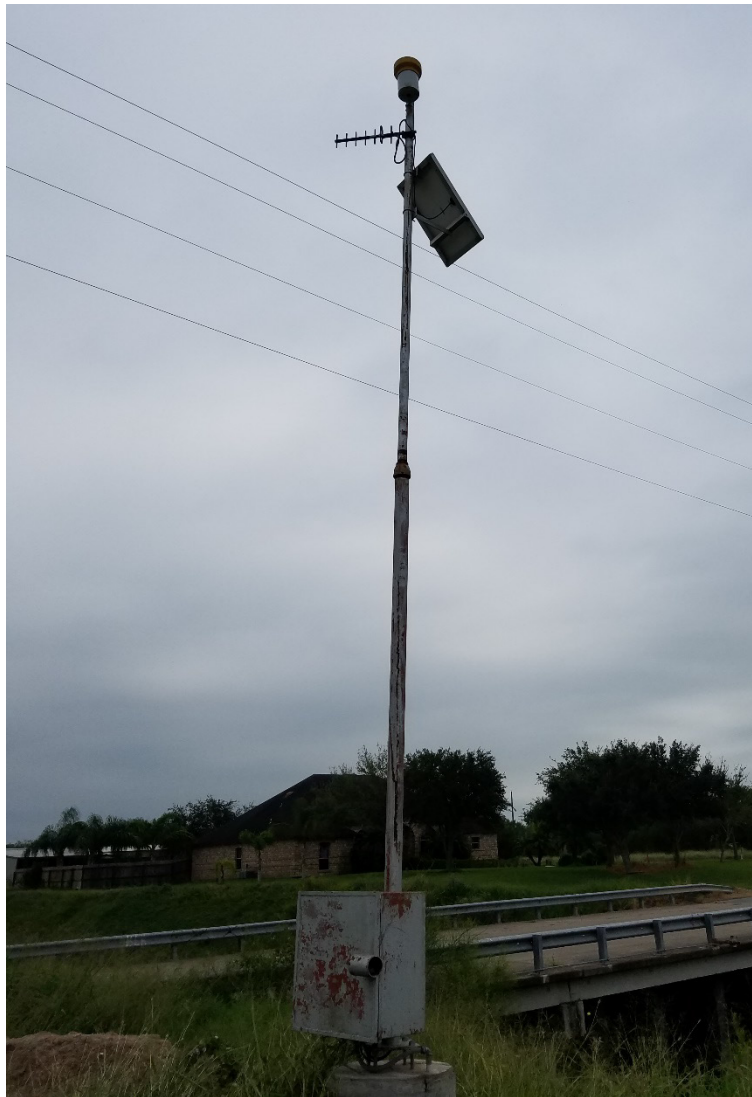
Figure 13: Typical CCDD5 Rain Gauge Setup

The rain gauges currently maintained by CCDD5 are all standard tipping bucket rain gauges. Details on manufacturer, diameter, or quality were not obtained. **Figure 13** illustrates a typical CCDD5 rain gauge setup at the top of a pole adjacent to the telemetry box, solar panel, and radio antenna.

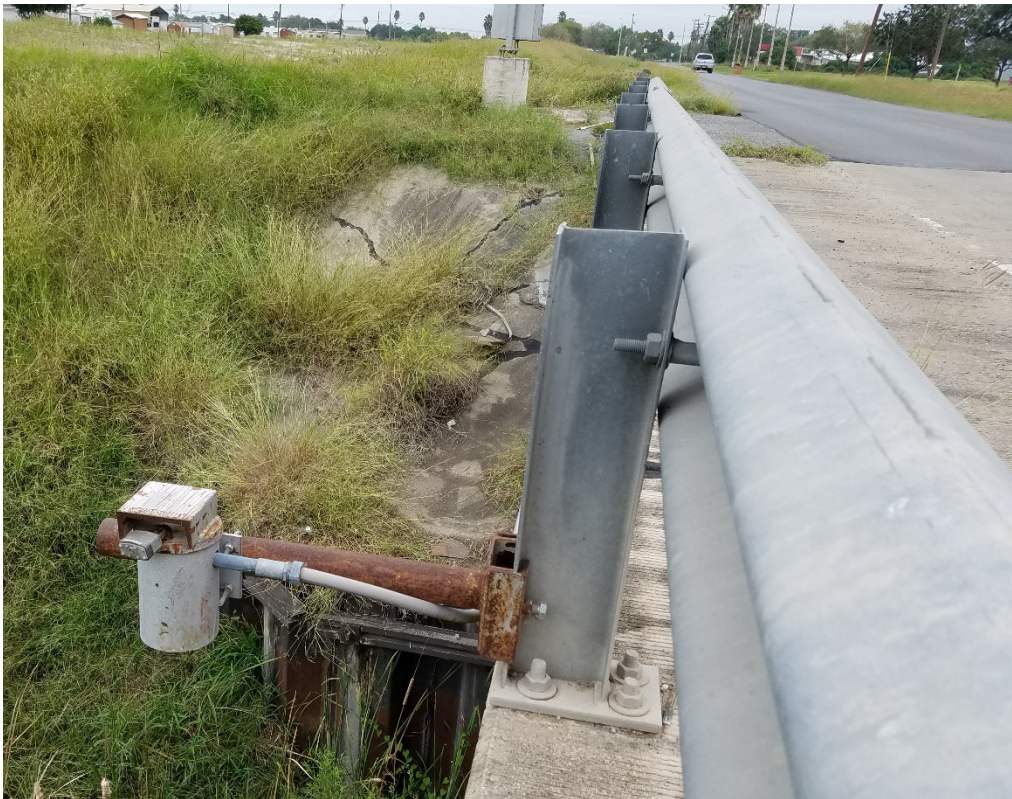
Figure 14: Typical CCDD5 Stage Gauge Setup

The stage gauges currently maintained by CCDD5 are all standard non-contact radar gauges mounted on the side of county or state-maintained bridges. Typically, these radar gauges are placed flush with the top of deck of the bridge, as local farm equipment often cross these bridges and at times have wide harvesting machines that would otherwise knock down a radar gauge that is mounted any higher. This approach helps with maintained gauge equipment longevity, relative to roadway traffic, but creates a situation where once a bridge is overtopped, the gauge is no longer of any use, as non-contact gauges cannot provide an accurate reading if they come into contact with the flood waters. **Figure 14** illustrates a typical CCDD5 stage gauge setup mounted to the side of a bridge, with telemetry equipment in the background.

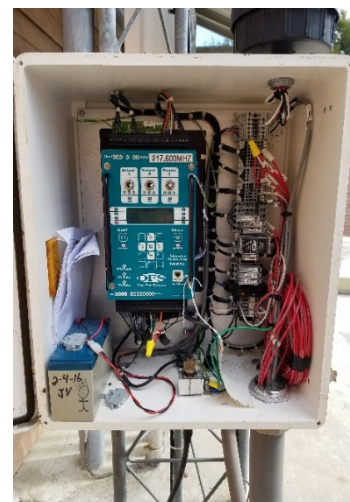
Figure 15: Example Gauge Telemetry & Battery Setup
(courtesy Scheibe, 2018)

Scheibe Consulting conducted a review of available rain/stream gauge equipment that may be of interest to CCDD5, when implementing FEWS improvements. An introduction to the main stage gauge and rain gauge equipment on the market is important to understanding the best direction forward for the district.

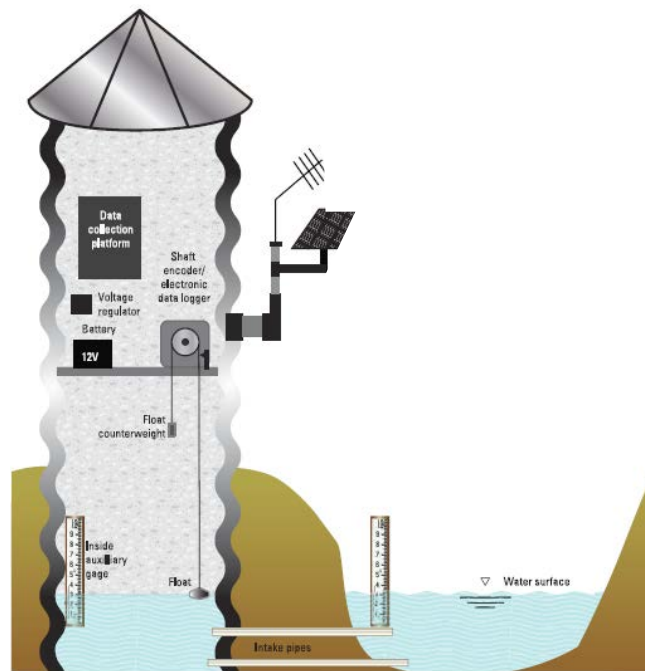
Figure 16: Basic Stilling Well Float System Schematic (Courtesy USGS [1])

Numerous stage gauges exist on the market and include traditional stage gauges, modern electronic stage gauges, and noncontact stage gauges. The traditional stage gauges consist primarily of a stilling basin coupled with a float to measure stage. The modern electronic stage gauges can be further broken down into bubbler gauges with non-submersible pressure transducers (P.T.s), and submersible pressure transducers (P.T.s). The modern electronic stage gauges appear to be the most commonly used systems (Based on interviews with regional owner/operators). The noncontact stage gauges can be further broken down into radar gauges, acoustic gauges, and laser gauges. Schematics of each of the basic systems are provided below in **Figures 16-19** (courtesy of the USGS [1]) for illustrative purposes.

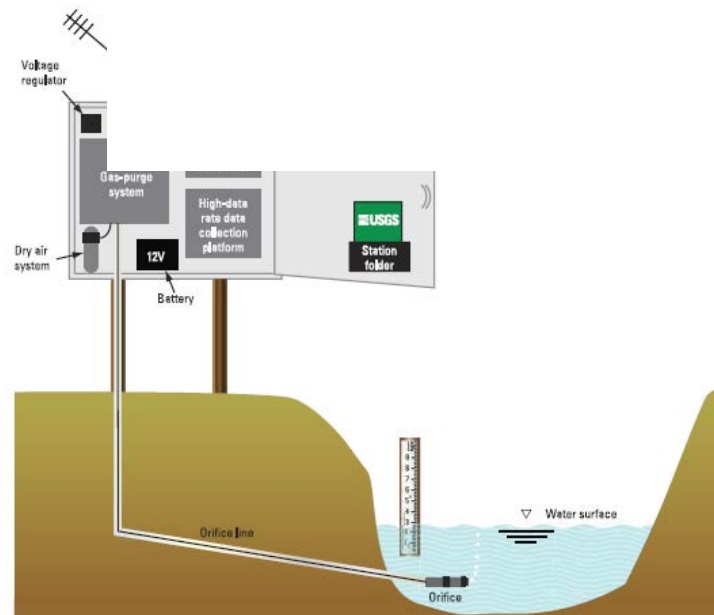
Figure 17: Bubble Gauge with Non-Submersible Pressure Transducer Schematic (Courtesy USGS [1])

Bubbler P.T.s on the market have accuracy ranges on the order of 0.05% [2] and appear to be relatively reliable systems often employed by agencies. These systems can operate in a wide temperature range, and have less risk of damage to the P.T. than submersible P.T.s.

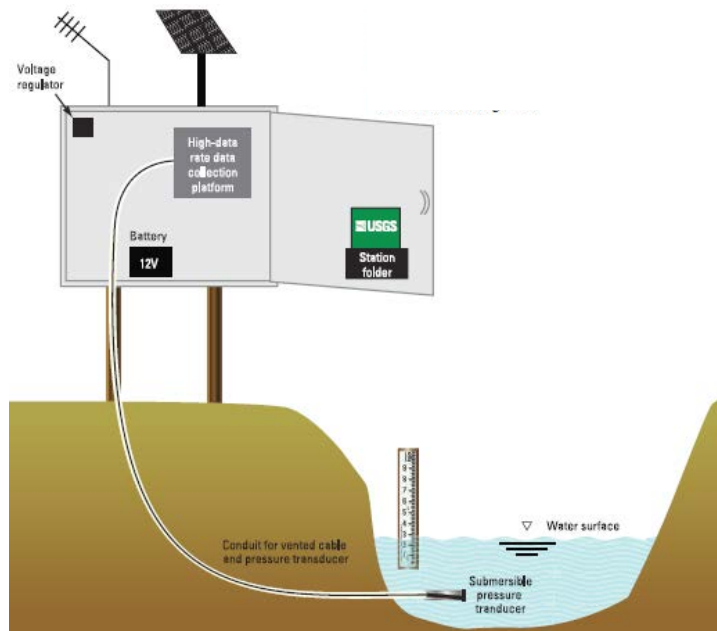
Figure 18: Submersible Pressure Transducer Schematic (Courtesy USGS [1])

Submersible P.T.s tend to have accuracy issues with large fluctuations in water temperature, and most cannot operate in freezing conditions [1]. The ideal conditions for this type of unit is in a deep stream or water body that has a minimal temperature change throughout the year. It should be noted that freezing temperatures can damage and destroy some of these sensors, and these sensors are subject to movement during large geomorphologically changing events, if not well

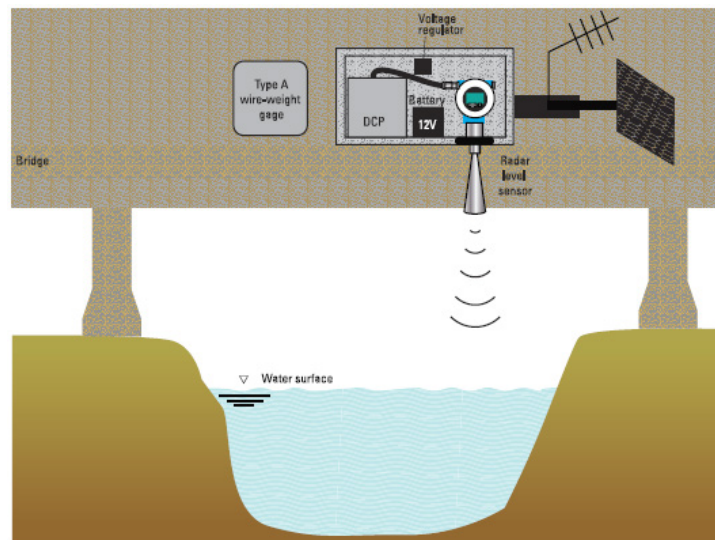
Figure 19: Noncontact Stage Gauge Schematic (Courtesy USGS [1])

It is important to discuss stage gauge accuracy. As per the USGS [1] stage gauges (to be used for flow measurements) should have an accuracy of 0.01 ft or 0.2% of the effective stage. This translates to an accuracy of 0.01 ft +/- during typical low-flow scenarios, and during flood stage (i.e. 30+ feet) the accuracy may diminish to ~0.1 ft +/- . This is important, as stage gauges setup for stage readings only, may not always meet these standards, which can have an impact on real-time stage reporting accuracy, potential real-time inundation mapping accuracy, model calibration accuracy (especially unsteady models), and potential future predictive stage accuracy. Typical sources of error for stage gauges include datum error (such as movement of the gauging device by nature or man) and instrument error (including clogged P.T. pipe or bubbler, animal/insect impacts/clogging, wind/vibrational effects on noncontact stage gauges, dust, and temperature effects).

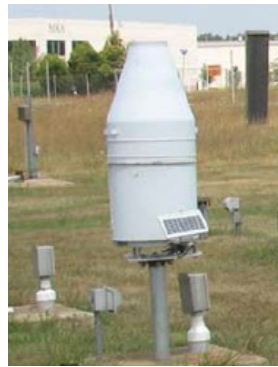
Figure 20: Example Capacitance Rain Gauge, Model 50202 Rain Gauge (Courtesy [6])

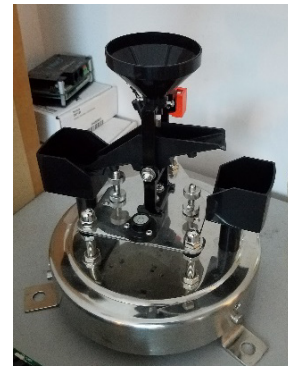
Figure 22: Example Tipping Bucket Rain Gauge (Courtesy SARA, 2018)

Similar to stage gauges, rain gauges have accuracy limitations that should be considered when selecting equipment. A review of several manufacturers of tipping bucket rain gauges, coupled with research performed for the American Meteorological Society indicates that measurement error is generally on the order of +/-1.5% for up to 2 inches per hour [7], and beyond that point the tipping bucket gauge tends to underestimate rainfall intensity [8]. The tipping bucket rain gauge also has limitations with measurement intervals on the order of 1-minute (ranging as high as +/- 20% error), and high winds can also play a role in inaccuracies with this type of gauge [7, 8]. Measurement durations on the order of 5-minute intervals can result in error on the order of +/- 10%, and with durations on the order of 15-minutes the error is much more acceptable (being on the order of +/- 2%) [8]. The weighing gauge has relatively accurate readings for both high intensity and low intensity rainfall events, and also tends to function well at measurement intervals on the order of 1-minute; but this gauge has a tendency to fail during longer duration events due to automatic siphon failure which can lead to significant data loss issues [8]. Newer models of the weighing rain-gauge developed by OTT, appear to resolve this siphon failure issue. The capacitance rain gauge performed similar to the weighing gauge for both high intensity and low intensity rain events. Capacitance gauges are also subject to error in high wind conditions, resulting in “instrument noise”. Also, capacitance gauges tend to have some extra error during extremely low rainfall intensity (on the order of 0.08 inches/hr or less), and measurements taken during extremely low intensity events should be interpreted with caution [8].

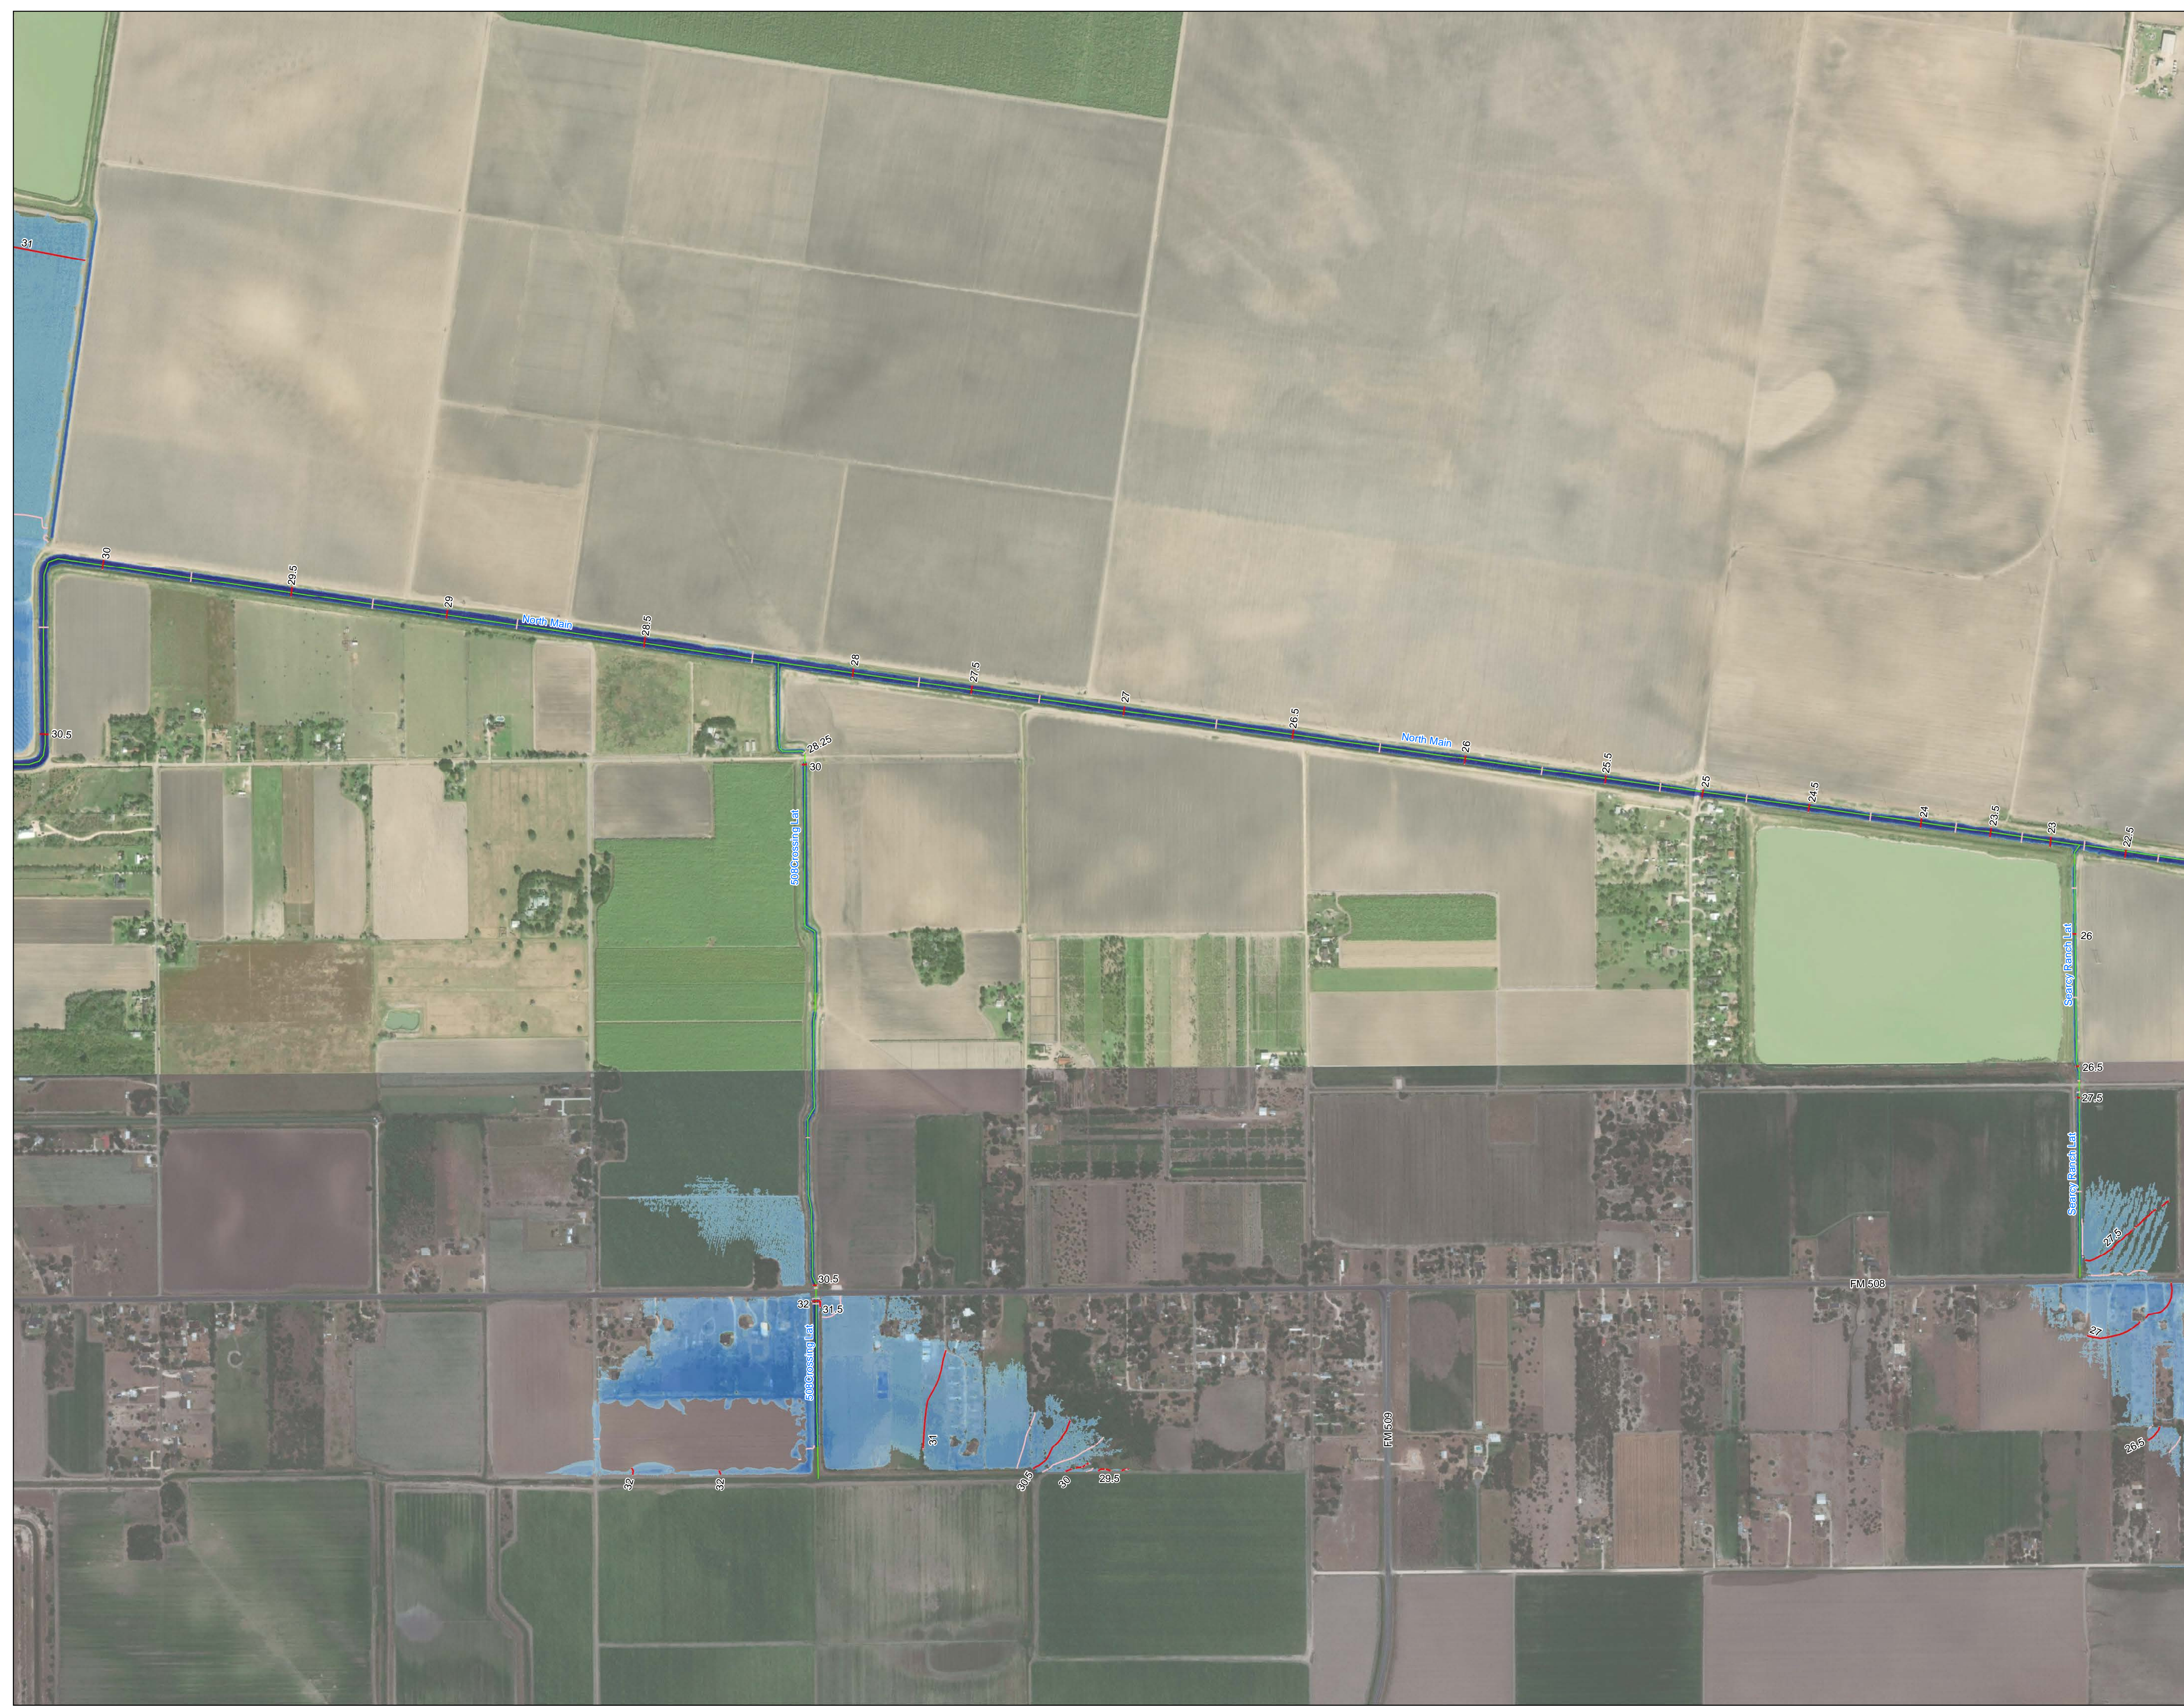
- Study Streams
 - 0.5 ft WSE Contours
 - 0.25 ft WSE Contours
- 100-Yr Floodplain Depths
- 0.0 - 0.25
 - 0.25 - 0.5
 - 0.5 - 1.0
 - 1.0 - 1.5
 - 1.5 - 2.0
 - 2.0 - 3.0
 - 3.0 - 4.0
 - 4.0 - 6.0
 - 6.0 - 8.0
 - 8.0 - 10.0

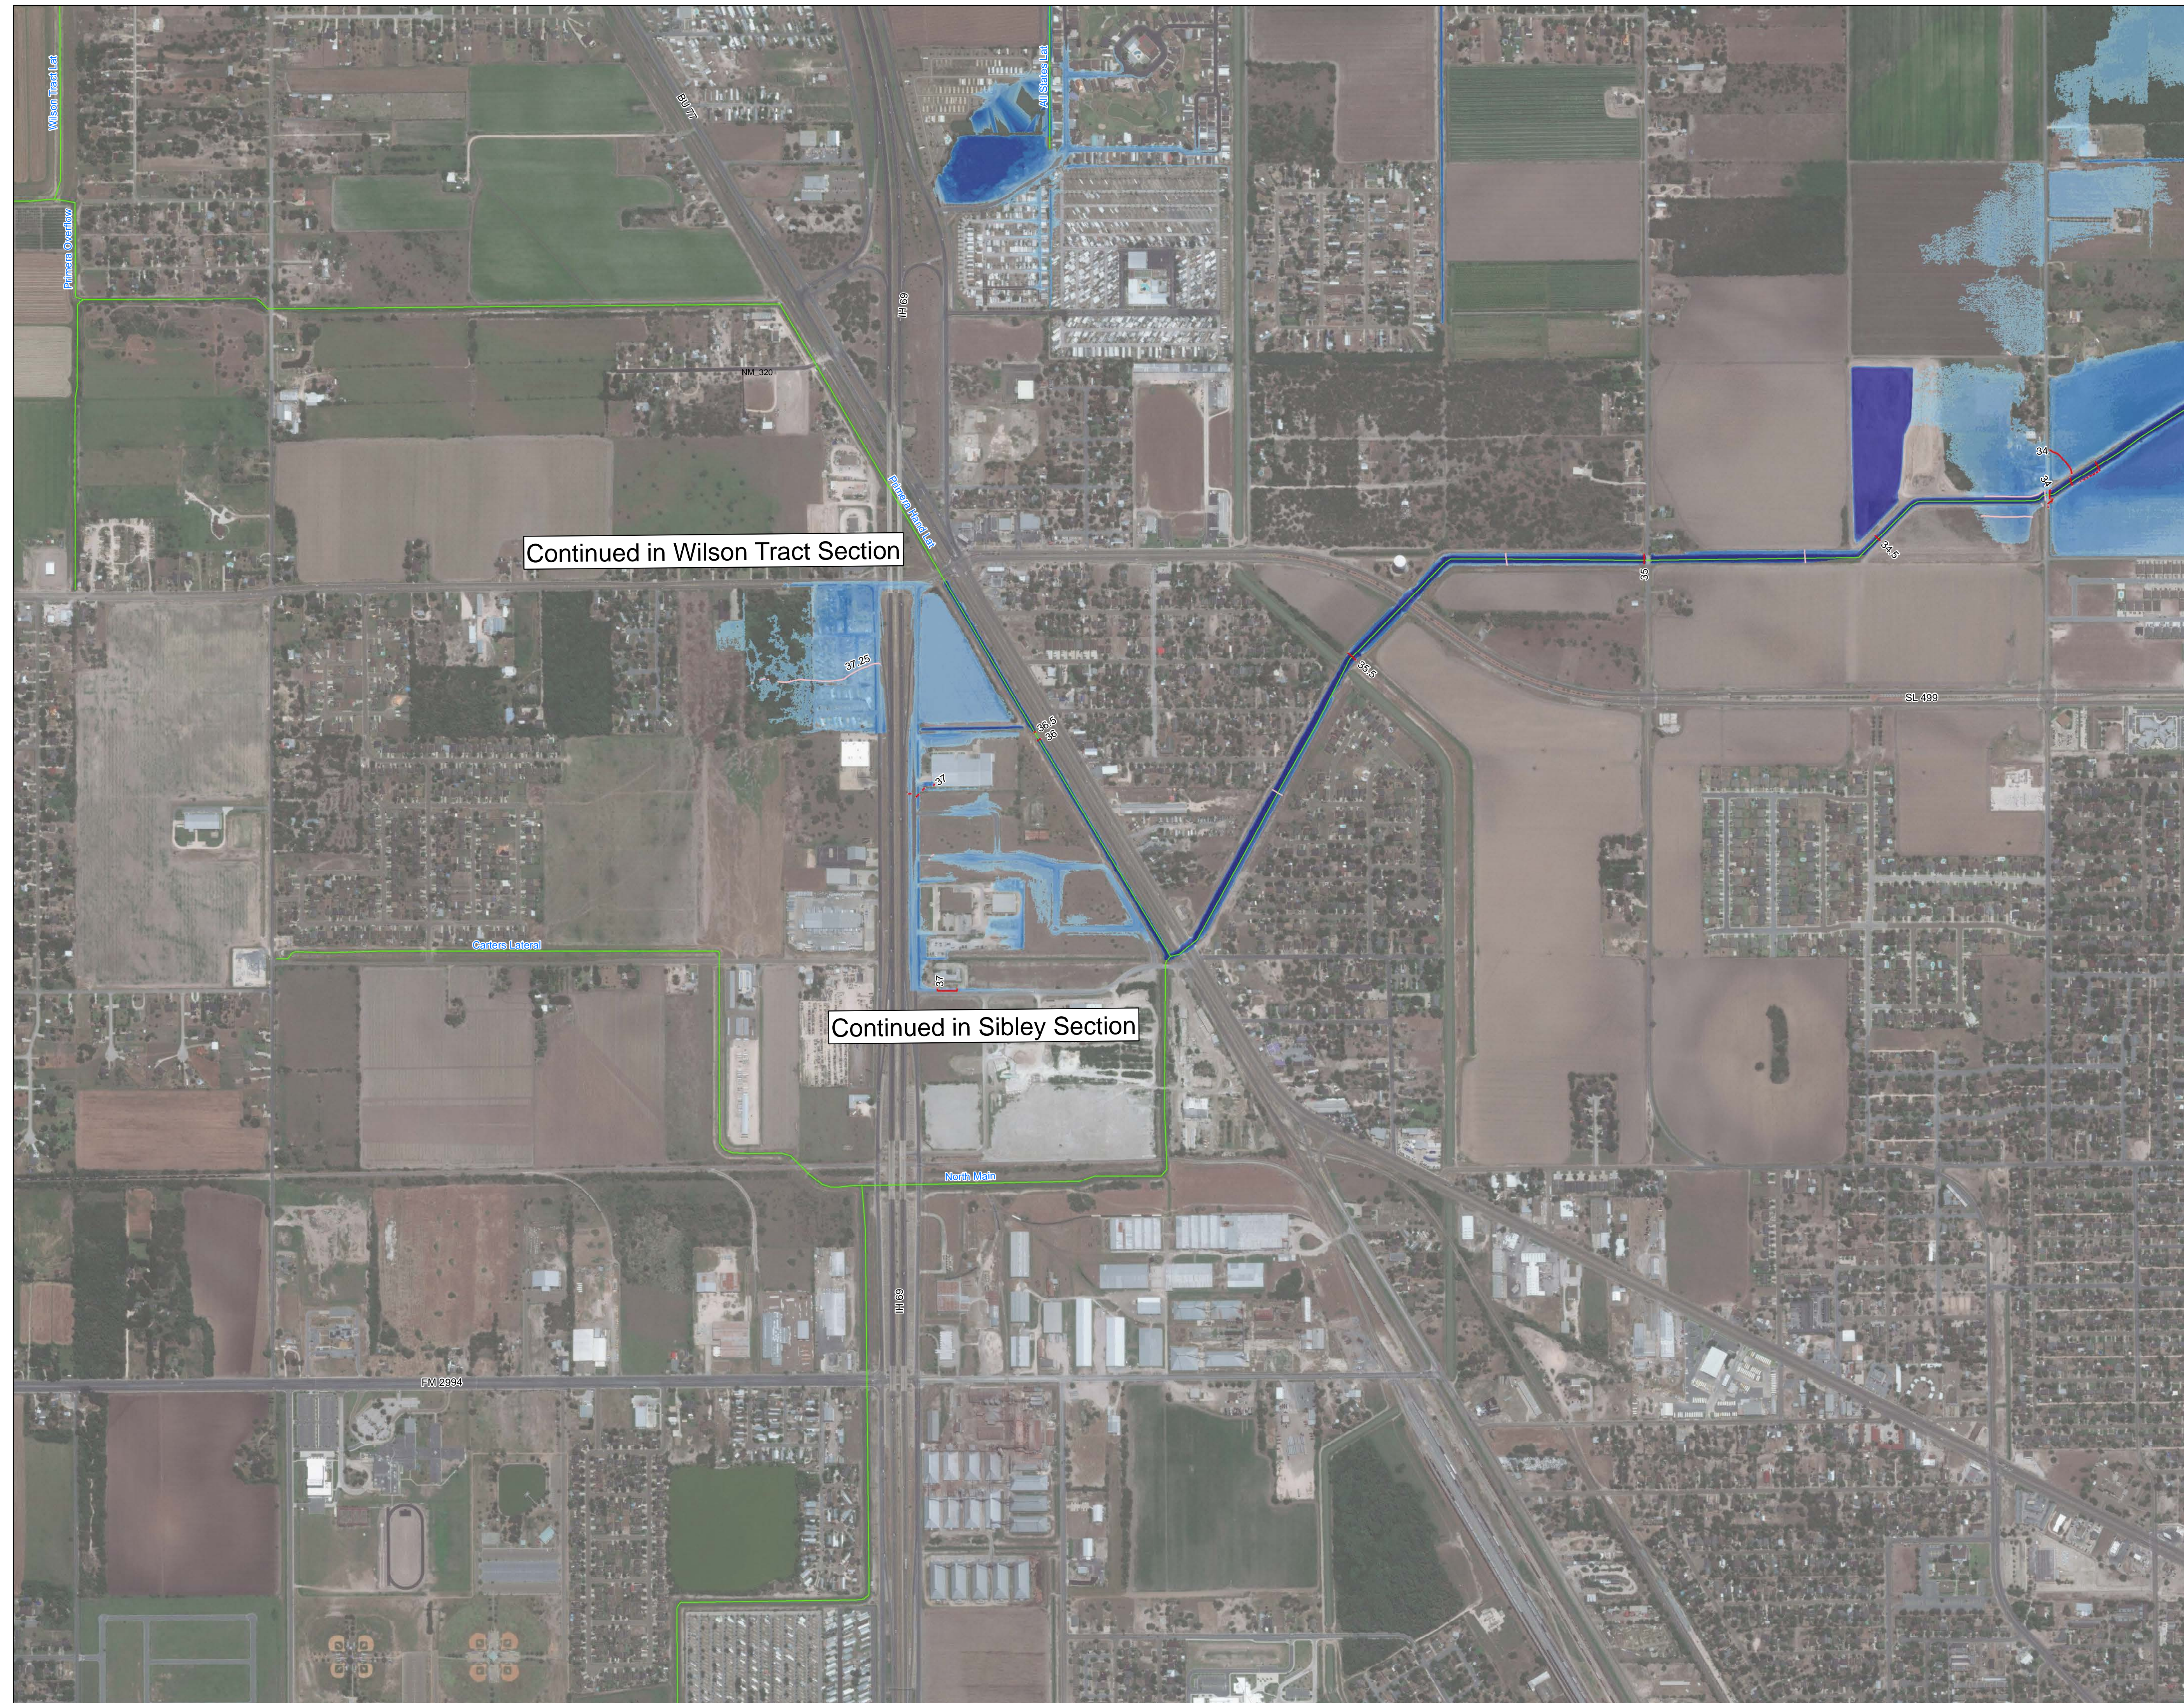
- 0.0 - 0.25
- 0.25 - 0.5
- 0.5 - 1.0
- 1.0 - 1.5
- 1.5 - 2.0
- 2.0 - 3.0
- 3.0 - 4.0
- 4.0 - 6.0
- 6.0 - 8.0
- 8.0 - 10.0

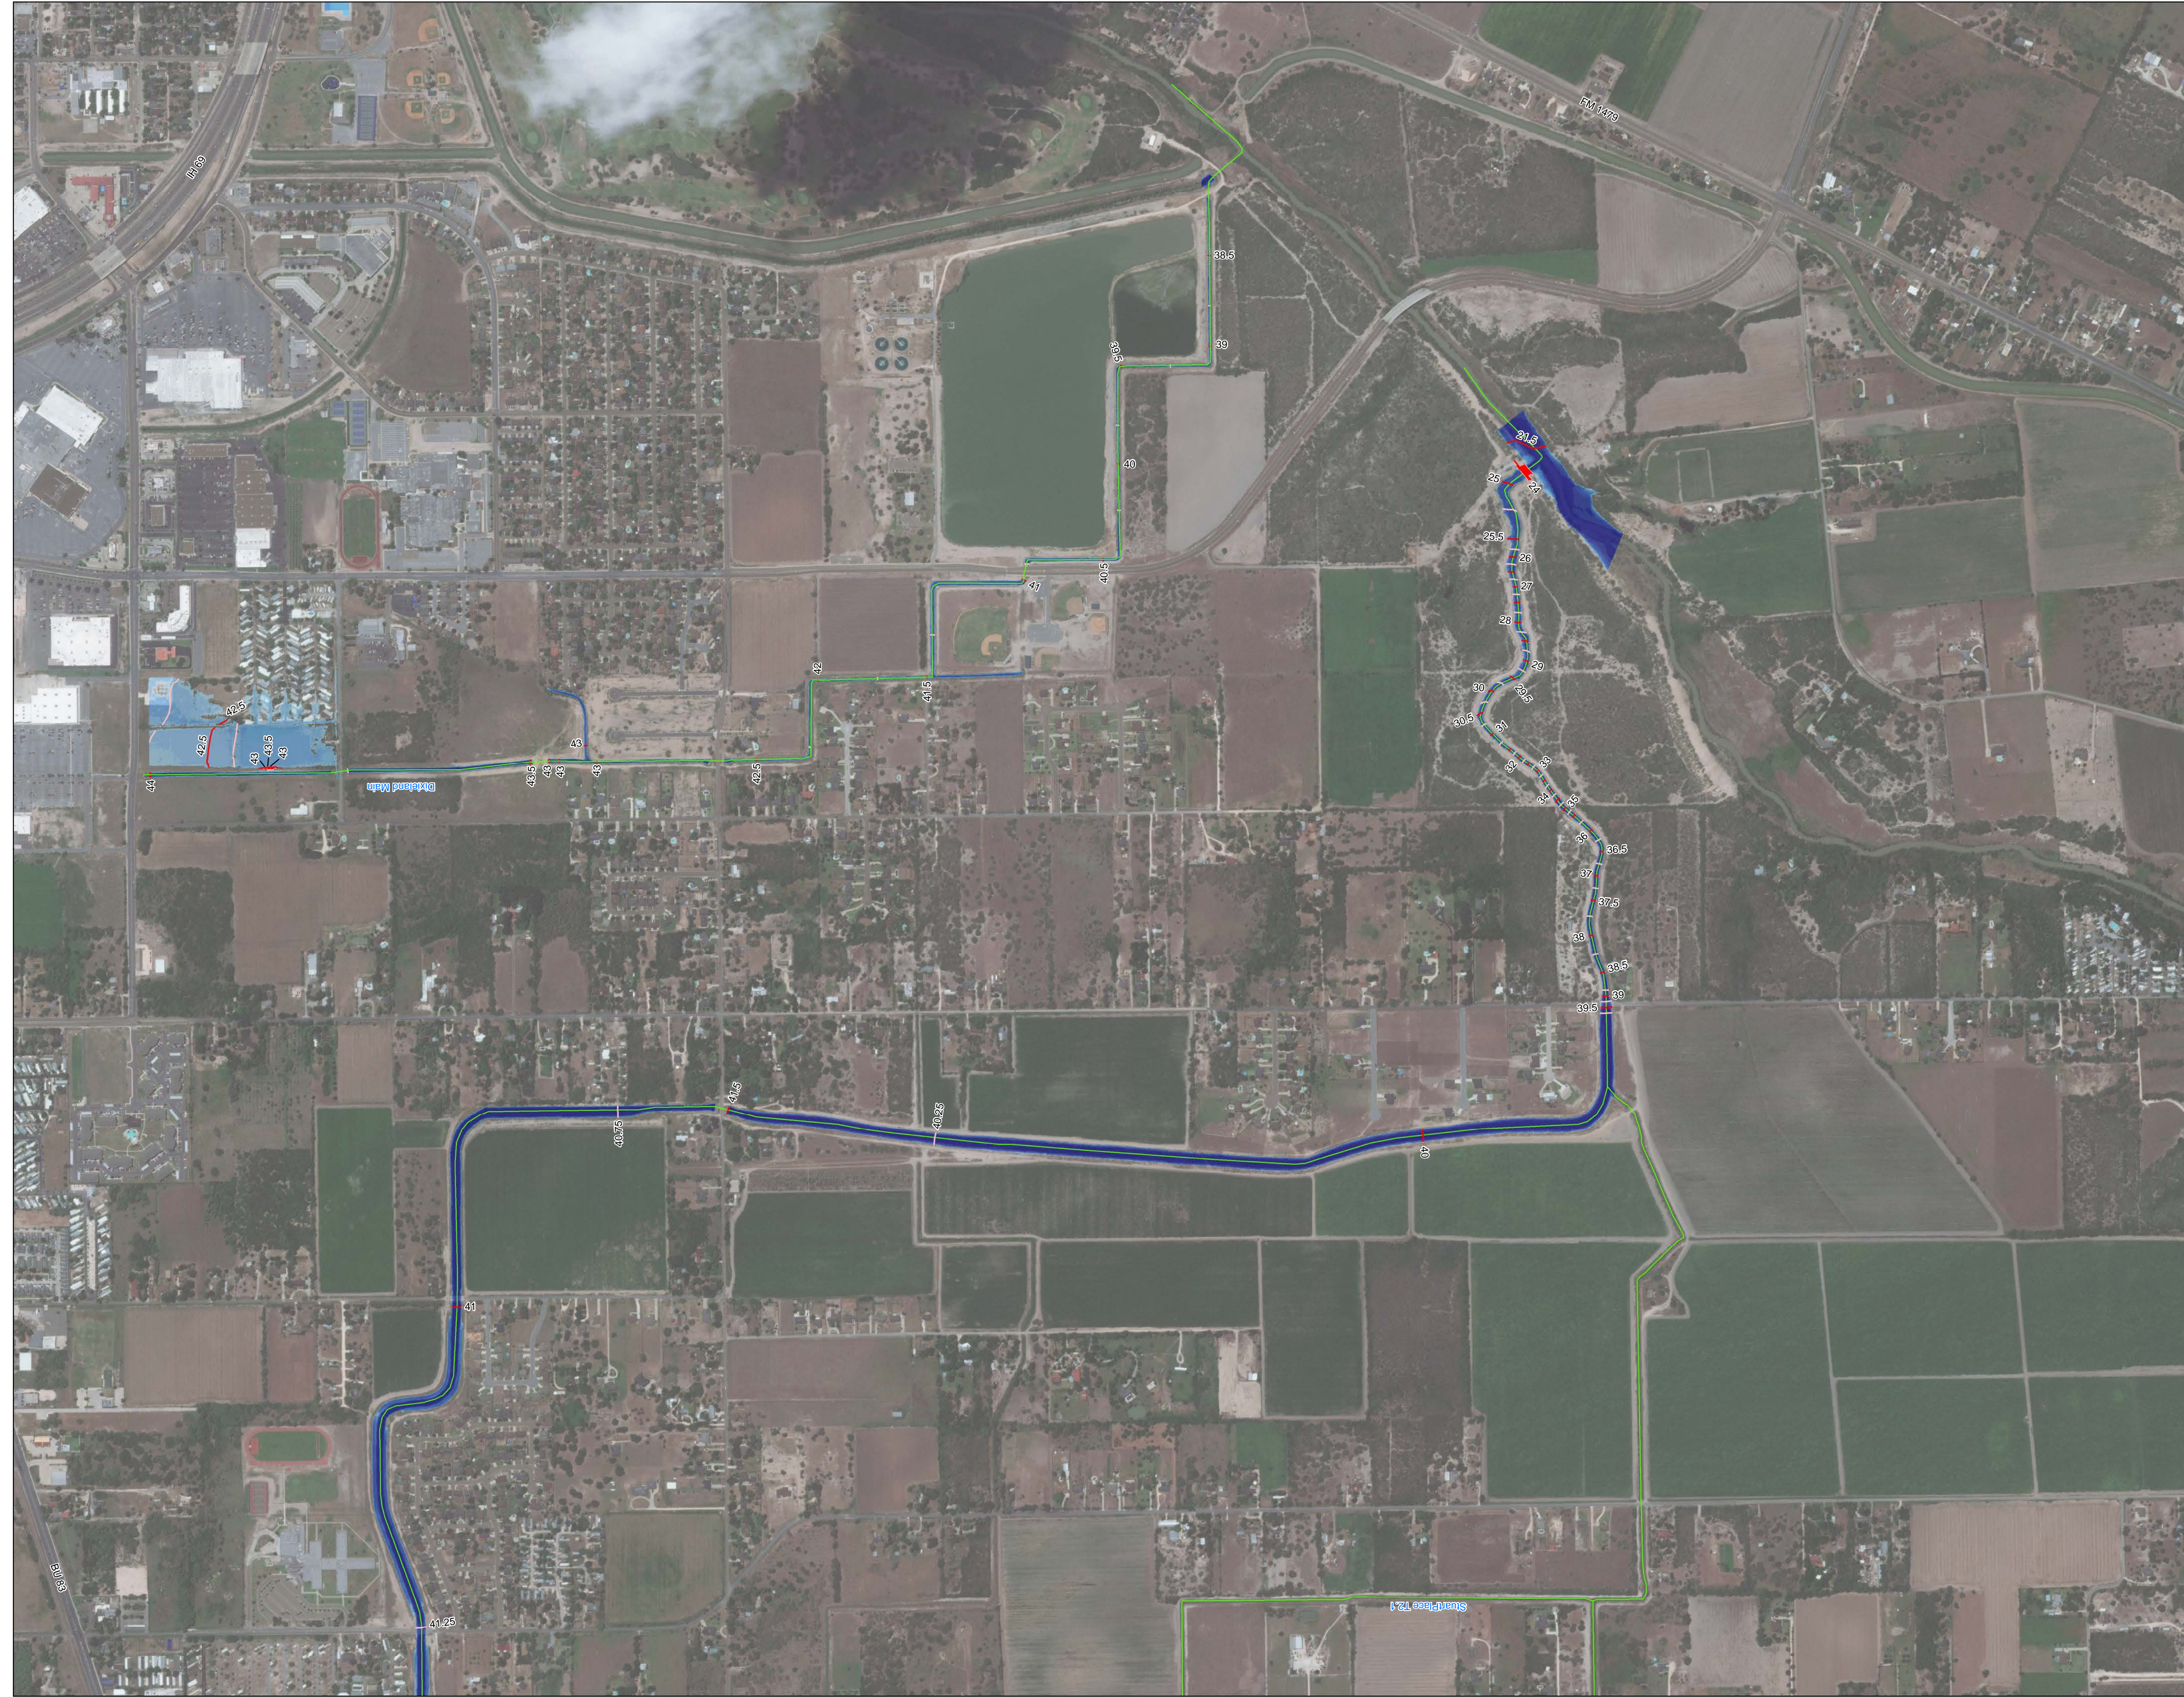
- Study Streams
 - 0.5 ft WSE Contours
 - 0.25 ft WSE Contours
- 100-Yr Floodplain Depths
- 0.0 - 0.25
 - 0.25 - 0.5
 - 0.5 - 1.0
 - 1.0 - 1.5
 - 1.5 - 2.0
 - 2.0 - 3.0
 - 3.0 - 4.0
 - 4.0 - 6.0
 - 6.0 - 8.0
 - 8.0 - 10.0

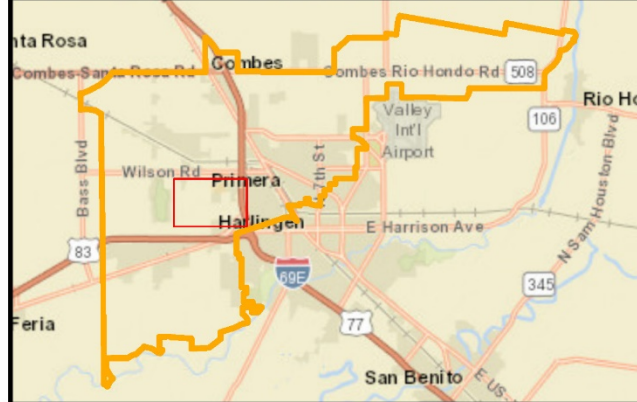
Alternative 1 – Optimize Regional Detention Pond on Sibley Lateral Upstream of Wilson Road

It was evident from the analysis of these options that a constriction in flow capacity associated with the existing grassy swale and 30-inch storm drain located along the Palm Valley golf course combined with additional flow coming in from Stuart Place drain through connecting ditches upstream of Stuart Place Road was not allowing the optimized pond to have a significant impact through the City of Palm Valley. The profile provided below shows the impact of the Stuart Place Drain overflows and Palm Valley constriction on the alternative results. Note that the profile is higher along the Palm valley golf course and Stuart Place Road and decreases upstream and downstream.

Proposed Detention Ponds

Overflow from Stuart Place Drain

Proposed upgrade to 2 - 10 X10 boxes

A detailed probable cost estimate was not determined at this time due to the minimal flood reduction impact of this alternative under current conditions. It is recommended that this alternative be reanalyzed at a future time when drainage capacity improvements have been made along the Palm Valley golf course. For this reason, Alternative1 has been given a low priority until additional downstream improvements can be analyzed as discussed. A map is included below showing details of the analysis for Alternative 1 and the location of the current flow capacity constriction.

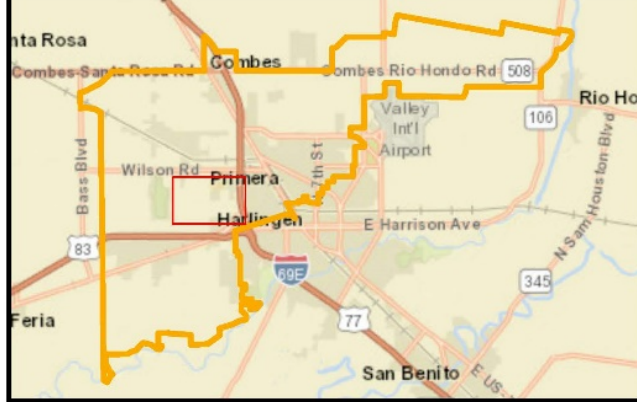
- Structures_Removed
- Study Streams
- Proposed 100-YR Floodplain
- Preliminary 100-YR Floodplain

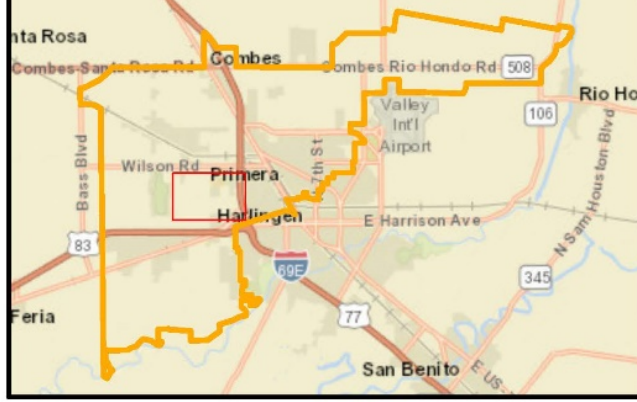
- Structures_Removed
- Study Streams
- Optimized Detention Basins
- Proposed Floodplain
- Preliminary 100-YR Floodplain

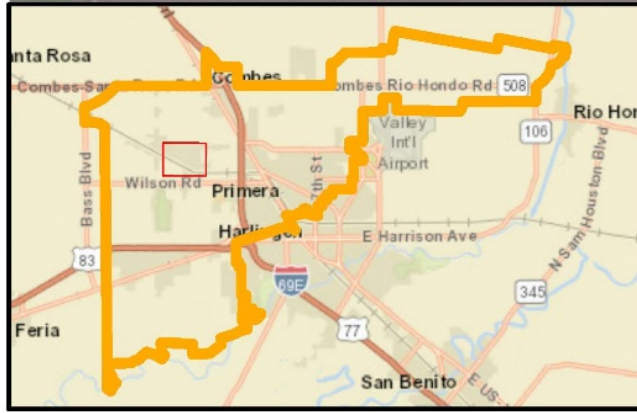
- Structures Removed
- Study Streams
- Proposed 100-YR Floodplain
- Proposed Detention Basin
- Preliminary 100-YR Floodplain
